QS Energy Provides AOT Testing Update

Update on AOT component testing

Key findings that prevented the AOT from operating during the Demonstration Project

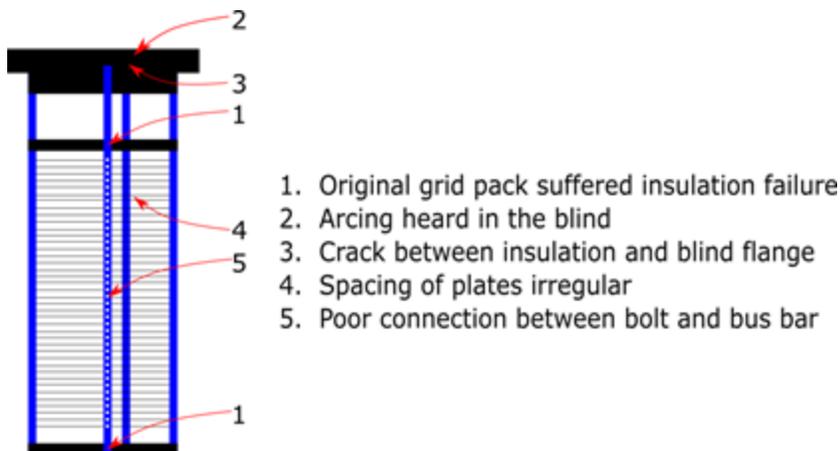
Diagram 1: Conceptual Drawing of Current Stack

A few major issues have prevented the AOT from achieving the voltage necessary to apply the AOT technology at the previous demonstration site. A conceptual drawing of the grid pack is shown in Diagram 1 with the locations of the problems identified with arrows.

We found that the current internals had significant spacing variation as indicated in Diagram 1 item 4. During the demonstration project the issue had been noted and insulated spacers were designed and made to improve plate spacing and to provide additional electrical isolation to the shell. The spacers worked to a degree, but we noted variation in plate spacing was still present. Given the limited voltage we had been able to achieve, it was not deemed a major issue at the time. During recent testing, we found that when the plates were isolated, arcing occurred at the closest point between them as expected. By investigating the grid pack where arcs formed, we found that there were a few locations where the gap decreased to almost half of the designed gap toward the centerline of the grid pack.

One of the major issues was arcing between assembly bolts and the negative bus bar. This issue was caused by the mechanical failure of spacers connecting the plates to the bus bar. The collapsed spacer created a very small gap, where there should have been strong metal to metal contact to connect, between the bolt and the bus bar. The gap allowed arcs to occur. Replacement spacers eliminated the issue.

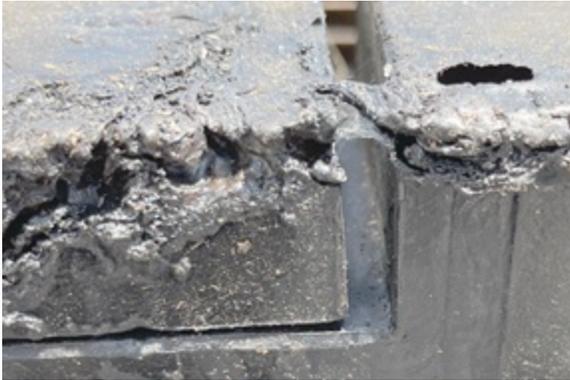
Figure 1: Photo of damaged insulation.

The original grid pack installed at the demonstration site was recently found to have two locations where the electrical insulation had been damaged, and arcing limited the amount

of voltage that could be applied. By isolating the components, we were able to recreate the failure in the original grid pack. The electrical insulation appears to have suffered many arcs and has melted. It is likely the damage started as a point failure and grew with more energy discharge. While we were not able to create a short circuit, it is possible and perhaps even likely the gaps became filled with carbon due to the electrical discharge, which led to a short circuit during the demonstration.

As reported on September 13, 2019 in the [Demonstration Project Status Update](#), the original AOT grid pack was replaced with the current grid pack to improve the intended reliability of the AOT by eliminating locations of potential arcing and short circuits. The implemented changes seemed to prevent damage like what is shown in Figure 1. We have been able to achieve higher voltages without similar damage. We believe this points to the new materials of construction being better for our application.

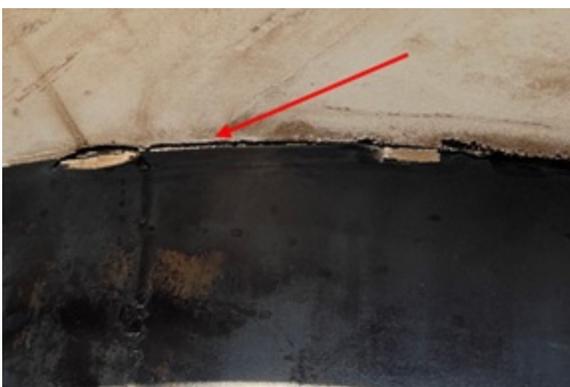
Figure 2: Insulation at blind flange.

As a result of our recent testing of the AOT, we discovered the blind flange required additional evaluation. Throughout testing, it was determined the blind presented some issues as well. Arcing can be heard from inside the blind. Additionally, a crack has formed where the insulation was cast on the blind flange-see Figure 2. The crack may only be a surface crack, or it may be a separation which could allow fluid to penetrate.

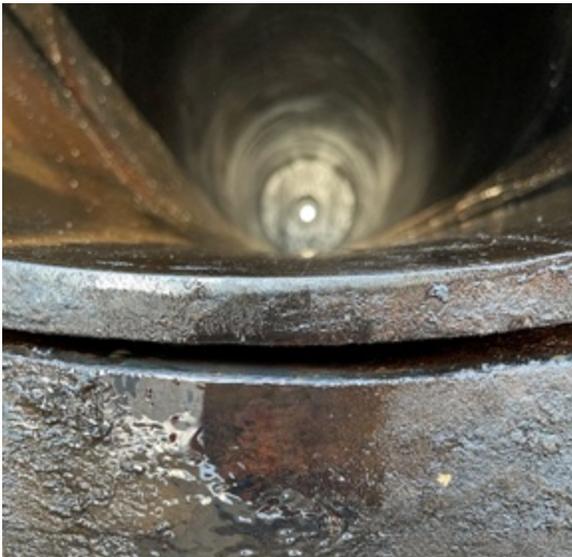
Figure 3: Pressure vessel insulation.

We also observed that the electrical insulation separated from the pressure vessel-see Figure 3. This observation has not yet correlated with any operational limitations and may not need to be addressed.
